Manhole Inspection Summary

Manhole # S33II1030MH

Insp Date: **3/27/07 10:27 AM**

Location Address: **MILBROOK RD**

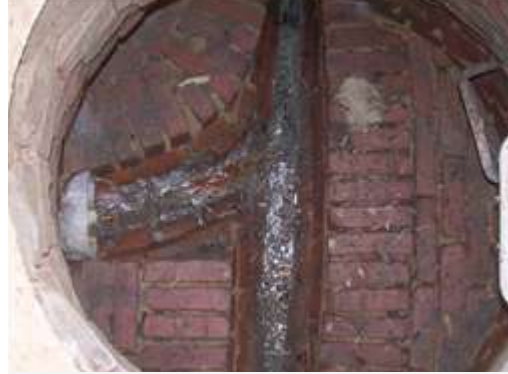
Top View

Bench deterioration and debris.

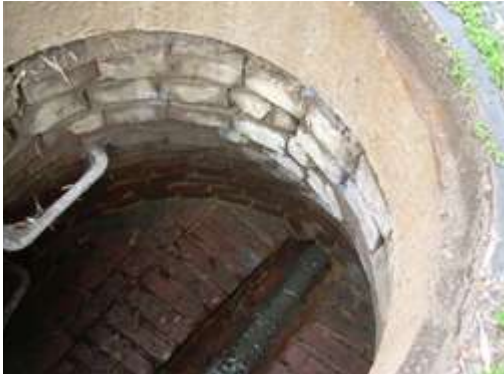
Defect

Frame leaks. Adjustment deterioration, loose brick and infiltration. Corbel infiltration.

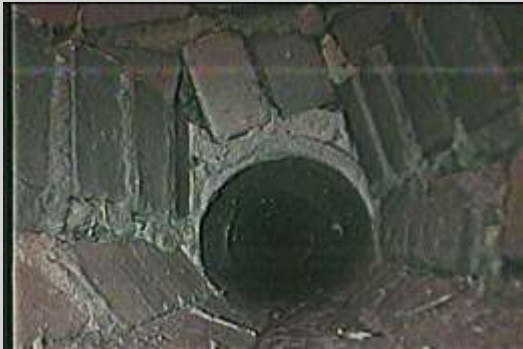
6 in. Circular Gravity Sewer Pipe Out @ 12 O'Clock

Infiltration: **None** Pipe Seal Cond: **Unknown**

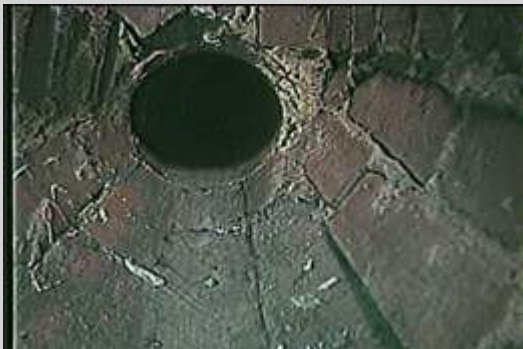
6 in. Circular Gravity Sewer Pipe In @ 6 O'Clock

Infiltration: **None** Pipe Seal Cond: **Broken**

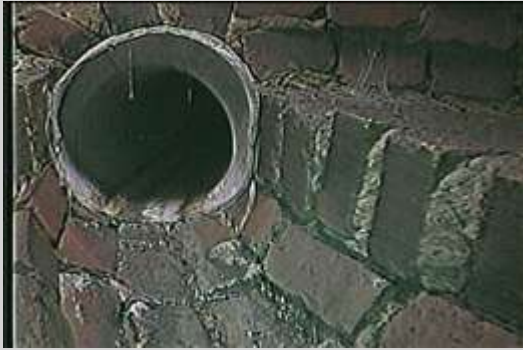
Pipe In @ 9 O'Clock

Barrel deterioration and infiltration. Channel deterioration.
